NPIC/CSD 548/65

27 OCTOBER 1965

NINH BINH COMPLEX
NORTH VIETNAM
2015N 10559E
[REDACTED]

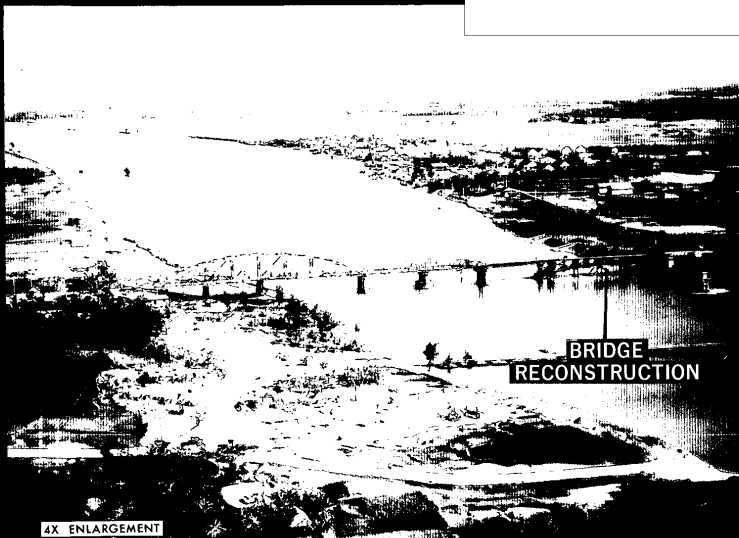
1. PRE-STRIKE PHOTOGRAPHY OF MARCH 1963, REVEALS NINH BINH COMPLEX AS IT APPEARED PRIOR TO AIR STRIKES ON THE NINH BINH RAILROAD AND HIGHWAY BRIDGE [REDACTED]

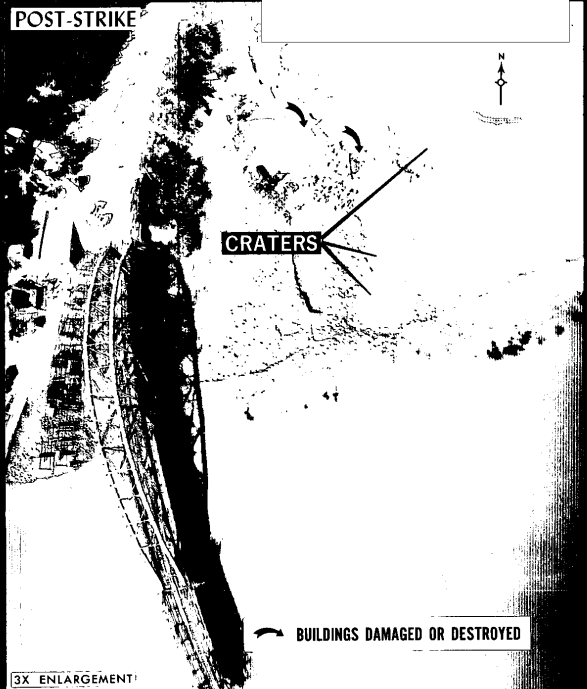
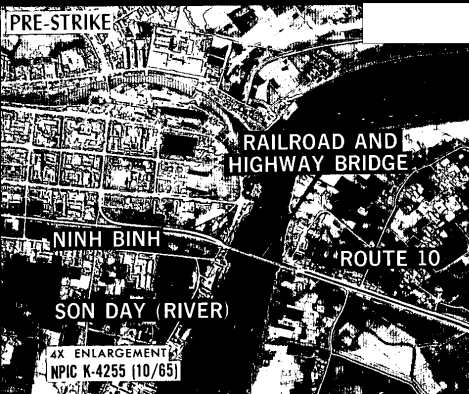
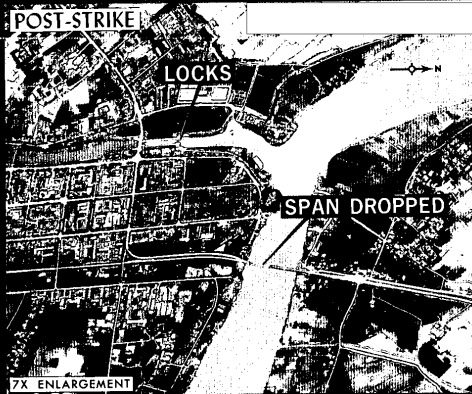
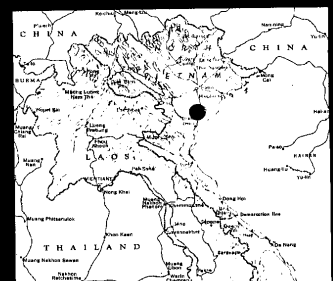
POST-STRIKE

[REDACTED], REVEALED A FOUR-SPAN (TWO THROUGH TRUSS-TYPE AND TWO DECK-TYPE SPANS) RAILROAD AND HIGHWAY BRIDGE OVER THE SONG DAI (RIVER) ON ROUTE 10 AT NINH BINH. THE SOUTHERN THROUGH TRUSS-TYPE SPAN HAD BEEN DROPPED INTO THE RIVER.

[REDACTED] REVEALS NEW BOMB DAMAGE TO THE CENTER CONCRETE PIER, STRUCTURAL DAMAGE TO THE SUPPORT BEAMS, AND THE DISLOCATION OF RAILS AND RAIL TIES, RENDERING THE RECENTLY RECONSTRUCTED BRIDGE UNSERVICEABLE. SIX DAMAGED OR DESTROYED BUILDINGS ARE OBSERVED AT THE NORTH APPROACH TO THE BRIDGE. SEVERAL BOMB CRATERS ARE ALSO NOTED IN THE AREA.
